Manhole Inspection Summary

Manhole # S43SS_009MH

Location Address: **1628 MONTPELIER ST**

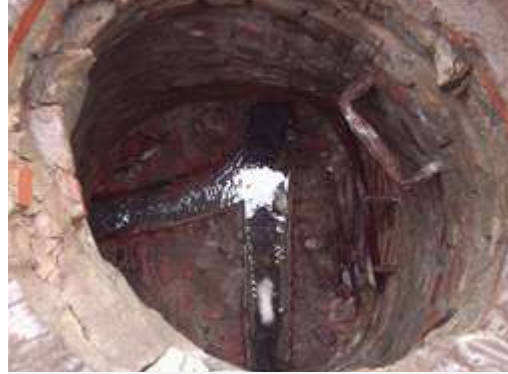
Top View

Barrel infiltration. Corroded steps. Bench and Channel debris.

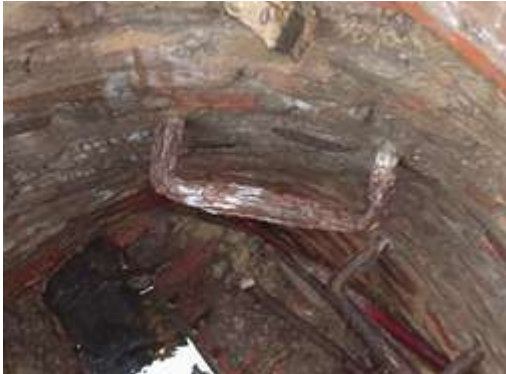
Defect

Barrel infiltration.

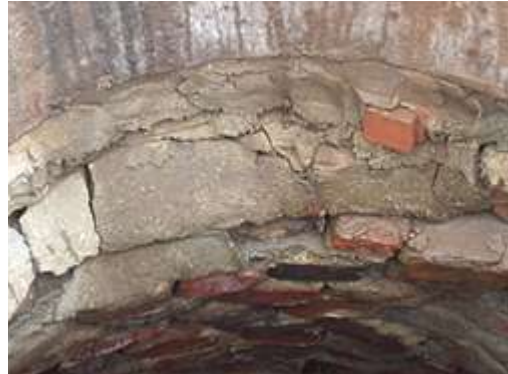
Defect

Corbel cracks, deterioration and infiltration.

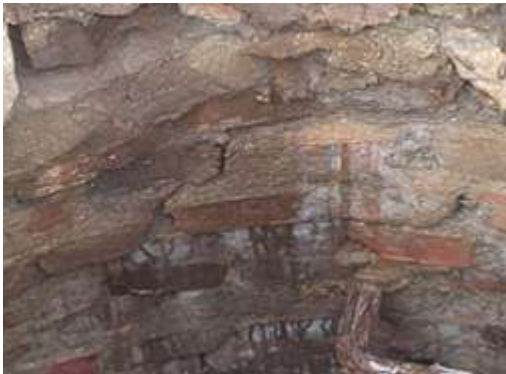
Defect

Barrel deterioration and infiltration.

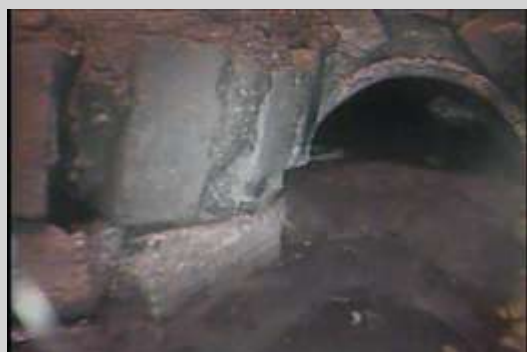
Pipe Out @ 12 O'Clock

Deposits: ☐ None ☒ **Mud** ☐ Sludge ☐ Debris ☒ **Grease**

Silt Depth: **3** (in.) Deposits Extent: **Medium**

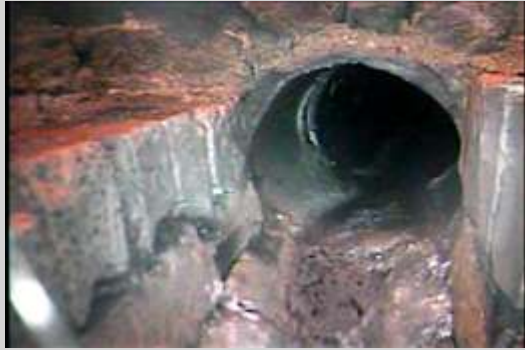
Pipe In @ 9 O'Clock

Channel deterioration.

Infiltration: **Evidence** Pipe Seal Cond: **Unknown**
